Disposable NPWT System Case Studies Chronic Leg Ulcer and Pressure Injury

CASE 1 - Chronic Leg Ulcer

CASE 2 - Pressure Injury

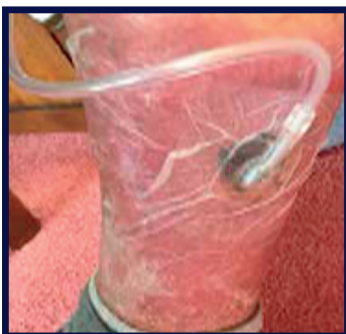
NEXA Dressing in situ

An 89 year old male presented with a chronic leg ulcer of 4 months duration without healing. Comorbidities include heart disease causing swelling in the limbs and aplastic anemia. The NEXA™ NPWT System was used to apply negative pressure treatment to the wound.

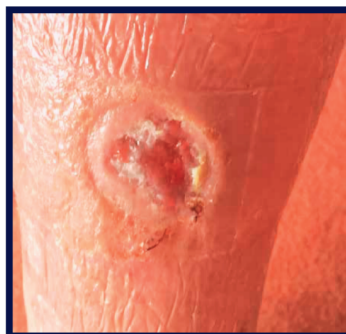
Day 19 of treatment

The wound size decreased markedly over the treatment period. At day 39 the wound was too small to continue with the Nexa System. The wound progressed to full closure within the next week using standard wound care.

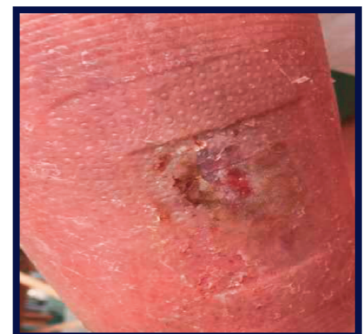
Day 39 of treatment

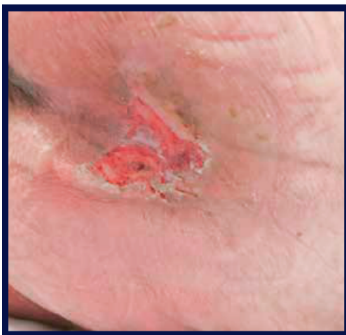
Day 1 of treatment

The NEXA System was applied when the wound measured 2.5cm x 3.0cm (day 1 photo). By day 10 of treatment, the wound had shrunk to such a degree that the NEXA System could no longer be applied. Of note, was a second wound that developed and was also treated with the NEXA System and was discounted after only one week.

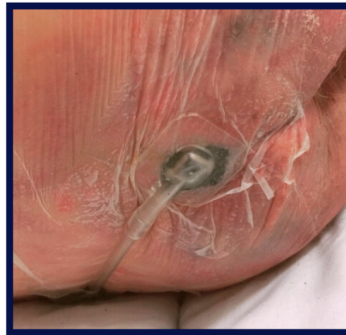
NEXA Dressing in situ

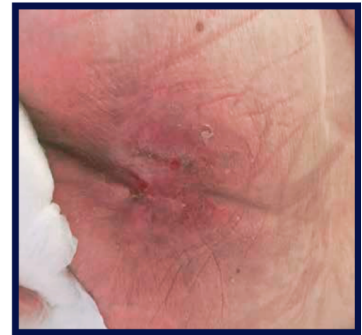
Day 10 of treatment
